Lessons learnt from the Deluge of Kedarnath, Uttarakhand, India

Piyooch Rautela

*Disaster Mitigation and Management Centre, Department of Disaster Management, Uttarakhand Secretariat,
Dehradun – 248 001 Uttarakhand, India. E-mail: rautelapiyoosh@gmail.com*

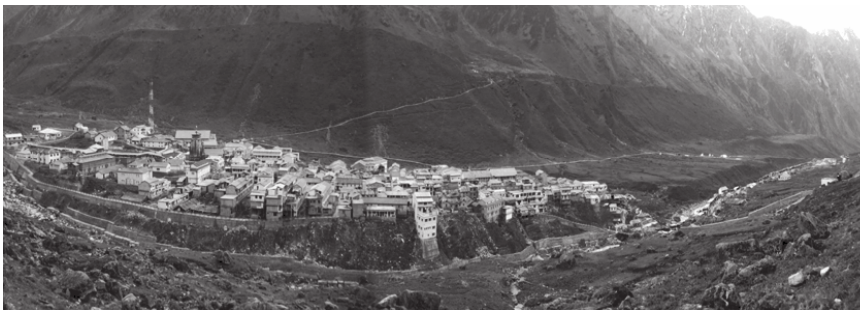
Figure 1 View of the temple township of Kedarnath, with camera looking east.

of 3581 meters above sea level (asl). The shrine of Kedarnath is located on raised middle portion of the deposit that is 20 – 25 meters above the level of Mandakini (3562 meters asl). For reaching Kedarnath(Fig. 1) one had to trek upstream along the course of Mandakini from Gaurikund for a distance of 14 kilometers.

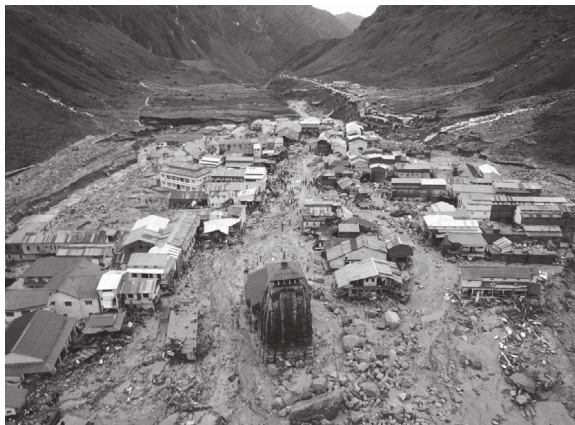
Figure 3 View of the Kedarnath township ravaged by the flood of June, 2013 with camera looking south.

Continuous rains caused the level of water in Chorabari Tal to rise. With the recession of the glacier the lake had a weak moraine barrier that could not withstand continuously rising hydrostatic pressure. Stage was thus set for a major disaster in Kedarnath and the barrier gave way around 0700 hrs on 17 June 2013. The volume of water was enormous and it carried with it huge glacial boulders and outwash material that choked the western channel of Mandakini and the flow of

water and debris got diverted towards Kedarnath township that was thus ravaged (Fig. 3). There was absolutely no warning and most people were taken by surprise and had no time to respond. Besides Kedarnath this event caused devastation in Rambara, Gaurikund, Sonprayag and other places.
