Brief Report on visit to Alaknanda Valley, Uttarakhand Himalaya during 22-24 June 2013

Surya Parkash, Ph.D.

National Institute of Disaster Management, New Delhi
suryanidm@gmail.com

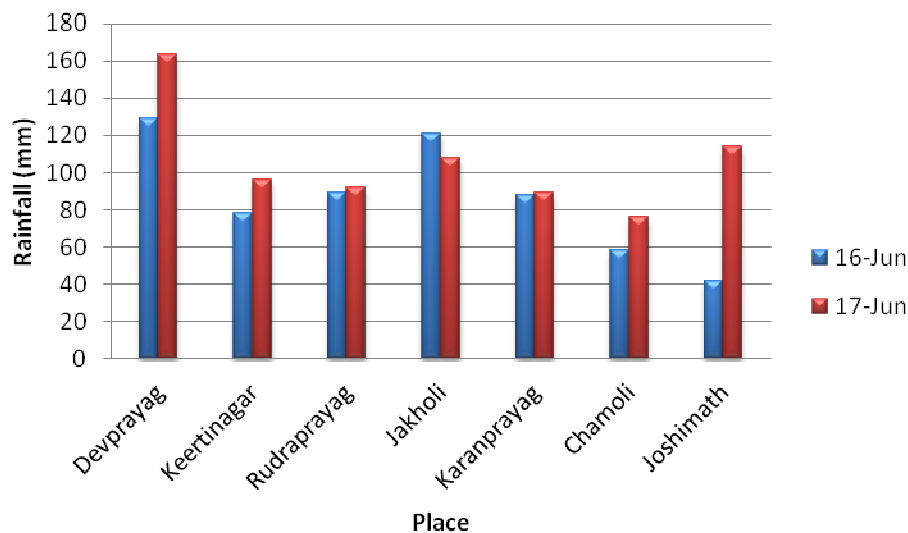
Figure 1: Rainfall Distribution in the visited affected areas (Source of data: IMD)

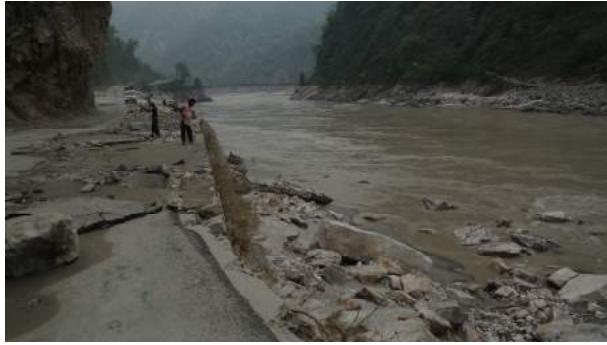
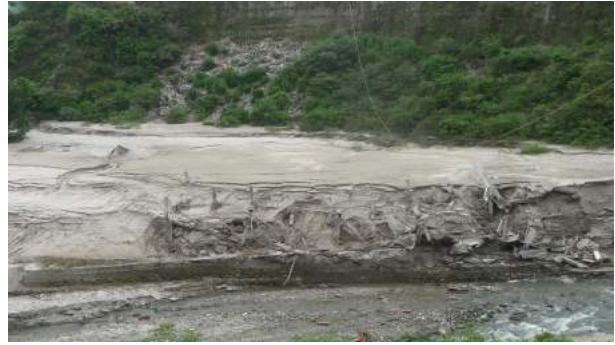
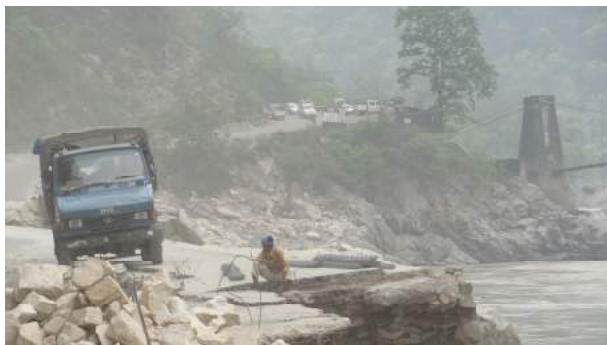
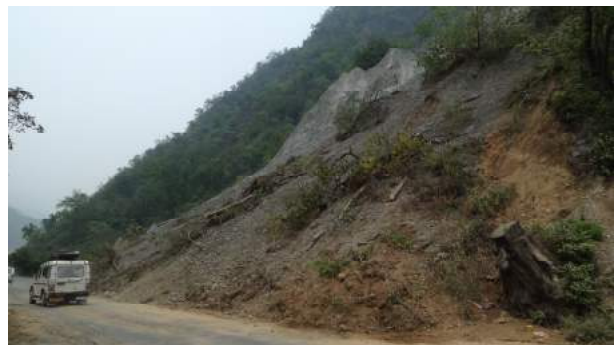
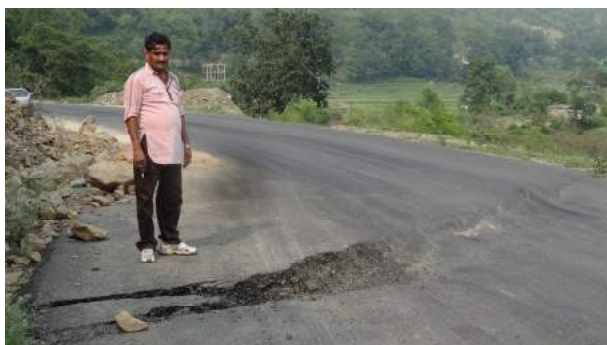
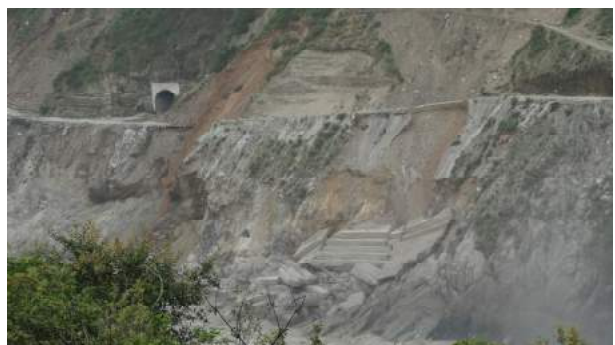
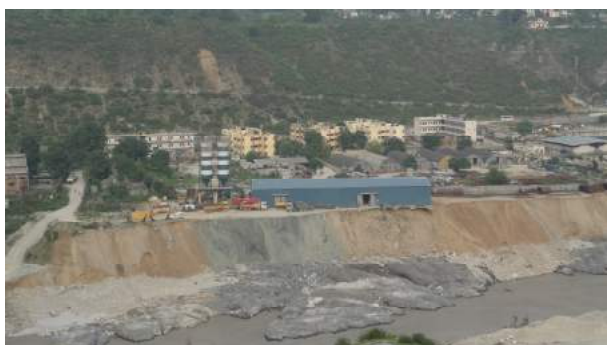
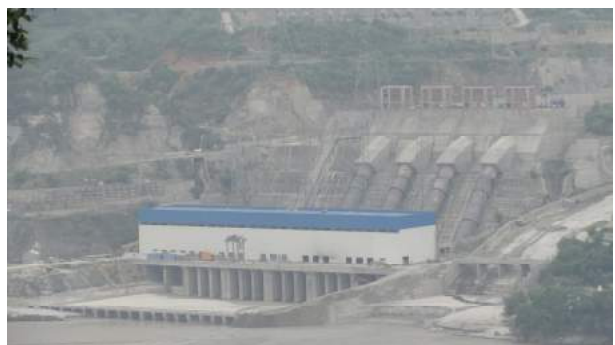
Photographs depicting damages to highway & hydel project along Rishikesh-Chamoli highway (Photo Courtesy: Dr. Surya Parkash, NIDM)

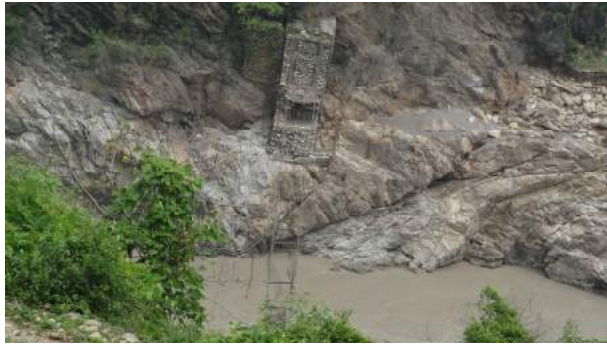
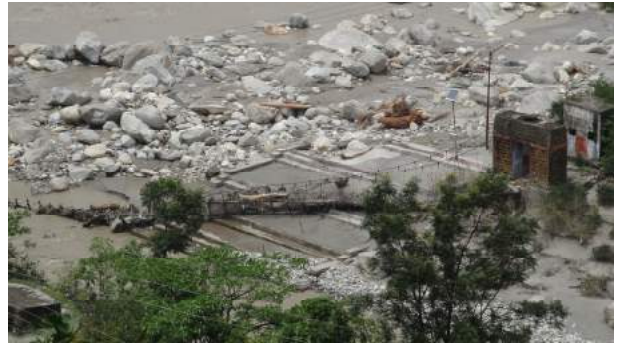
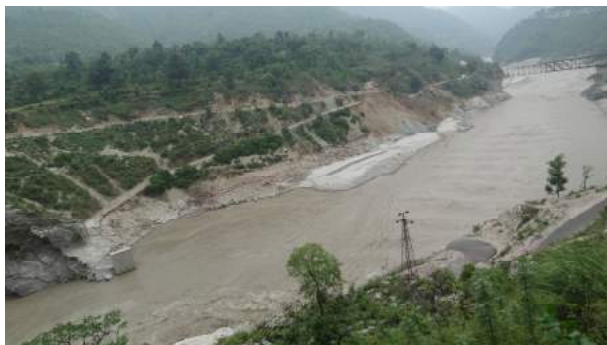
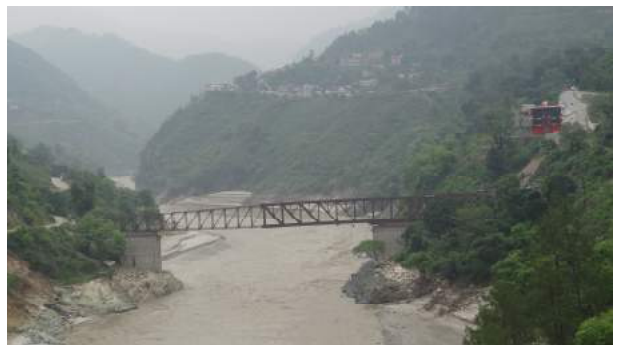
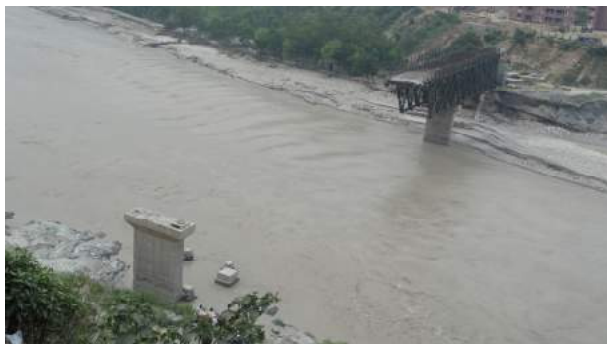
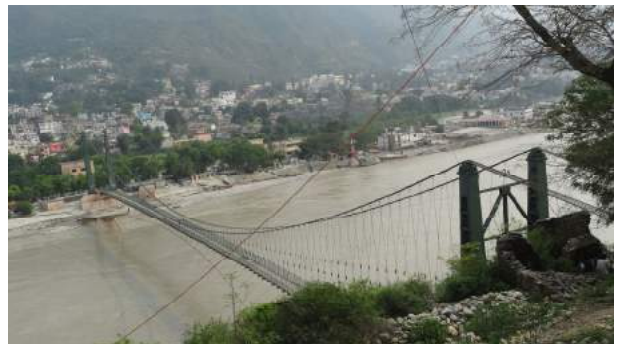
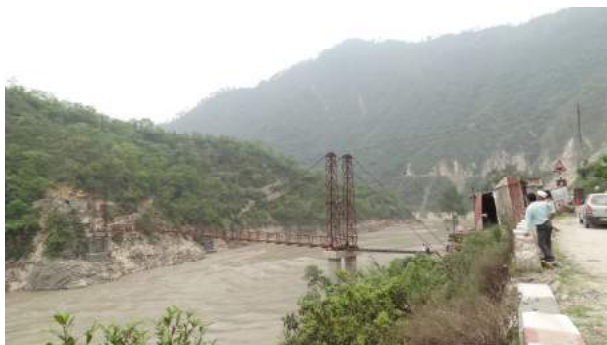
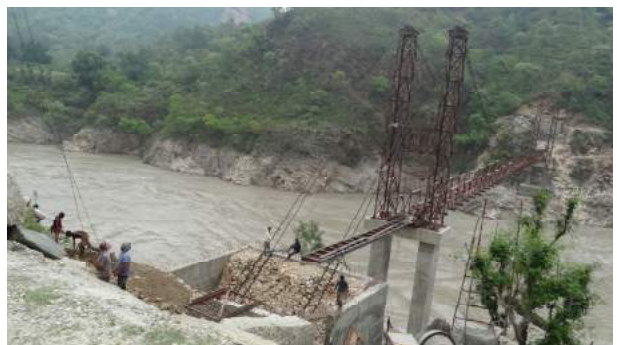
Photographs revealing damages to bridges along Rishikesh-Chamoli highway
(Photo Courtesy: Dr. Surya Parkash, NIDM)

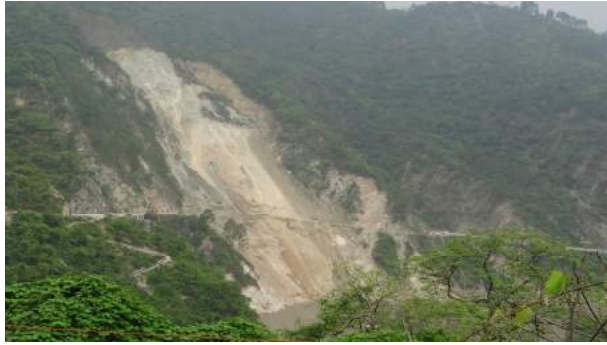
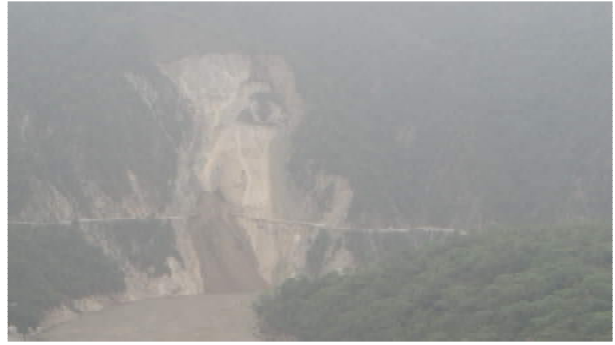
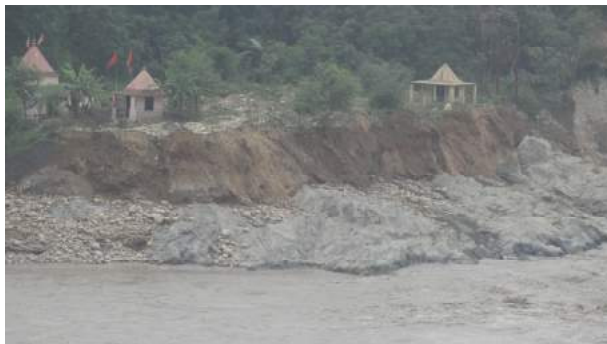
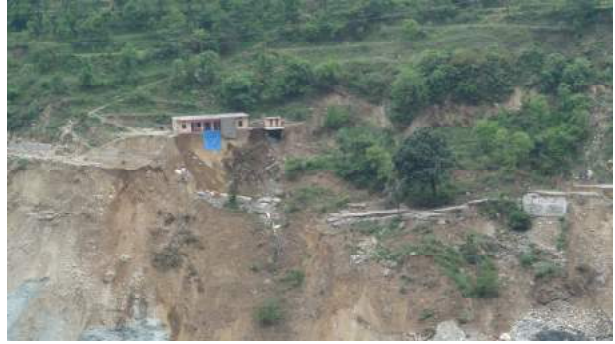
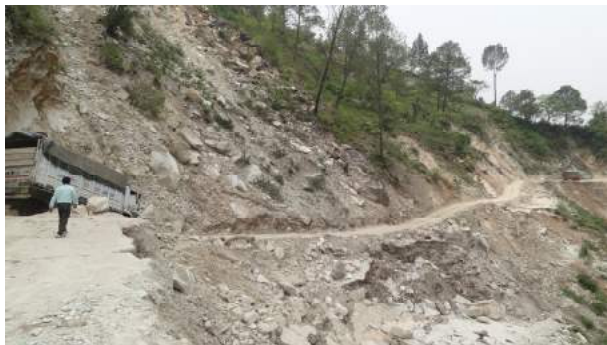
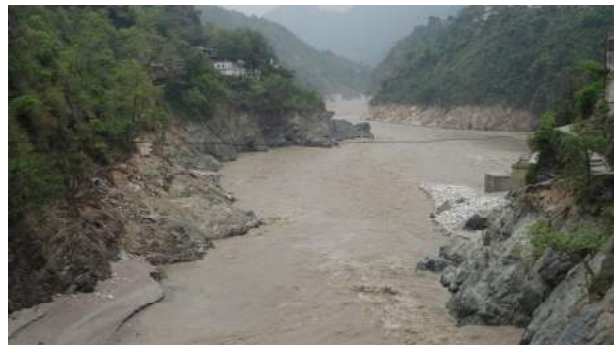
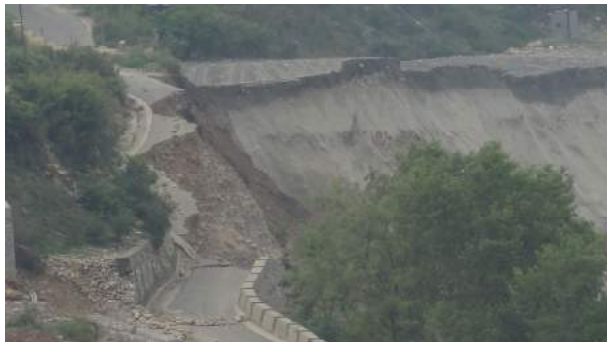
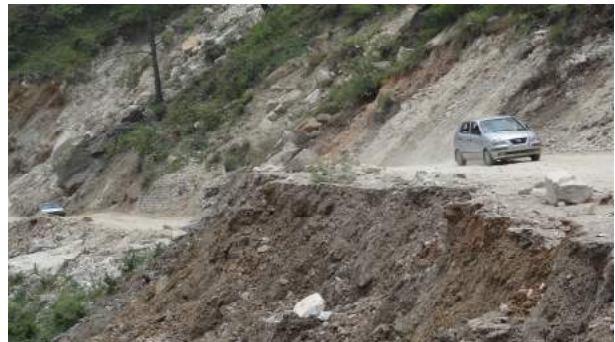
Photographs depicting occurrence of landslides and subsidence along Rishikesh-Chamoli highway (Photo Courtesy: Dr. Surya Parkash, NIDM)
