## Cloudburst and landslides in Uttarakhand : A nature`s fury?

**ABSTRACT.** Cloudburst is one of the major natural disasters in Uttarakhand state of India and this brings flash floods, landslides and massive destruction of property and lives almost every year in the state. The present paper discusses about flood and landslides which occurred due to cloud burst and heavy downpour in between 14 to 17 June, 2013 in the state. Uttarakhand is very susceptible to landslides and almost three fourth of the total geographical area of the state comes under severe to high landslide risk zone. The catastrophe started with cloud burst near Rambara in Rudrapur district and due to torrential and continuous rainfall, almost all the major rivers and especially the Mandakini and the Alaknanda swelled up. Overflowing water reservoirs of the region catalysed the severity of the event. About one tenth of the upper catchment area of Mandakini river swept away due to flood and landslide. This was the deadliest hazard in 80 years' history of the state which affected about 80,000 people. The paper reflects the nature's supremacy over human potentials and advocates the balanced man-nature relationship, es

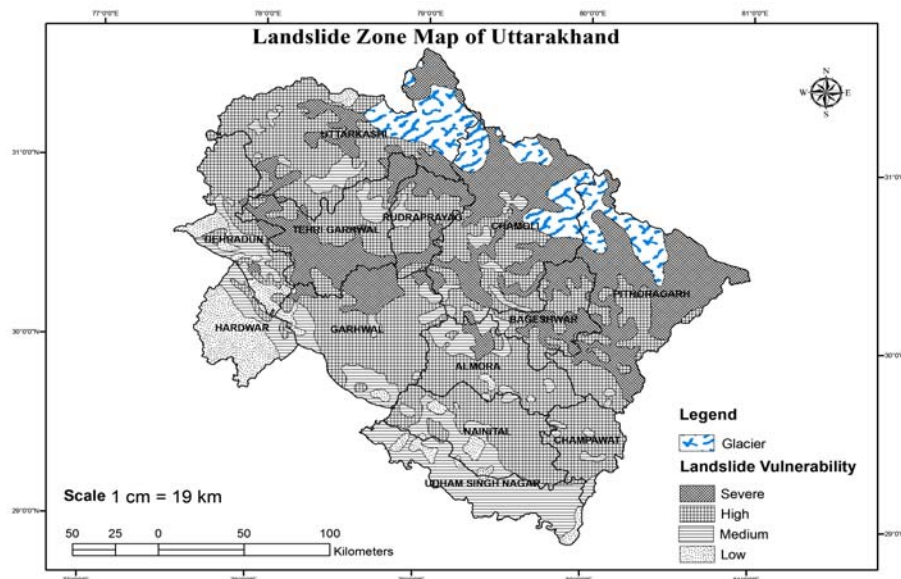
Fig. 1. Landslide zone map of Uttarakhand

About 70 per cent of total geographical area of the state is registered under high to severe landslide vulnerability zone (Fig. 1).

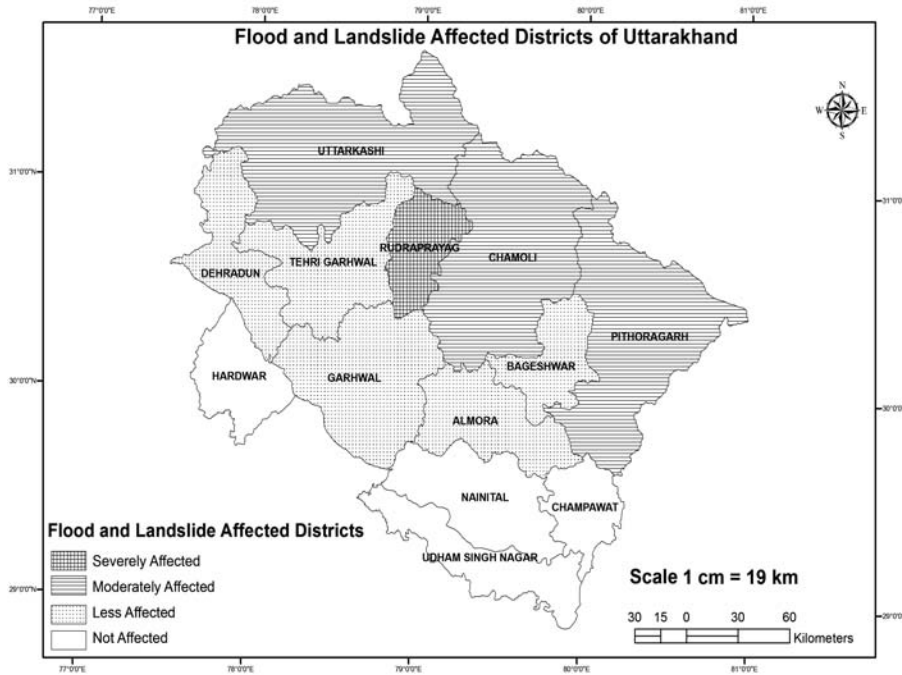
Fig. 2. Flood and landslide affected districts of Uttarakhand

Out of thirteen, nine districts were affected by flood and landslides of which three districts namely Chamoli, Uttarkashi and Pithoragarh were heavily affected while the Rudraprayag district was the worst affected (Fig. 2).

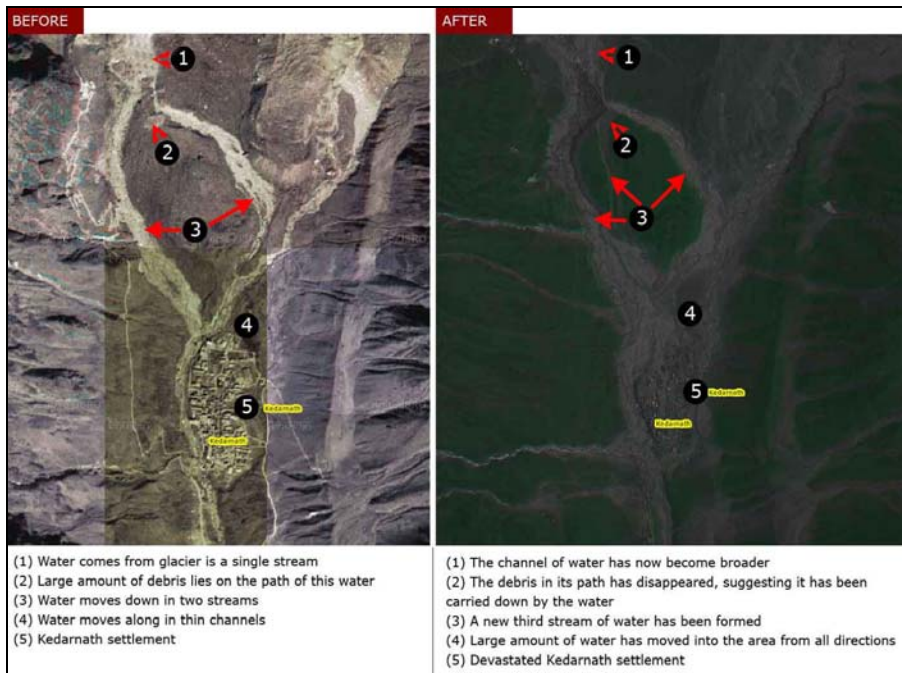
Fig. 3. Details of flash floods and landslides (Source : NRSC)

Due to a cloudburst resulting in heavy rains on 14 June, 2013, in Kedarnath, the epicentre of the devastation, the banks of the lake Chorbaria Tal (Ghandi-Sarovar) situated above Kedarnath town burst causing flash floods and landslides and the town covered with 6 feet of sludge (Fig. 3).

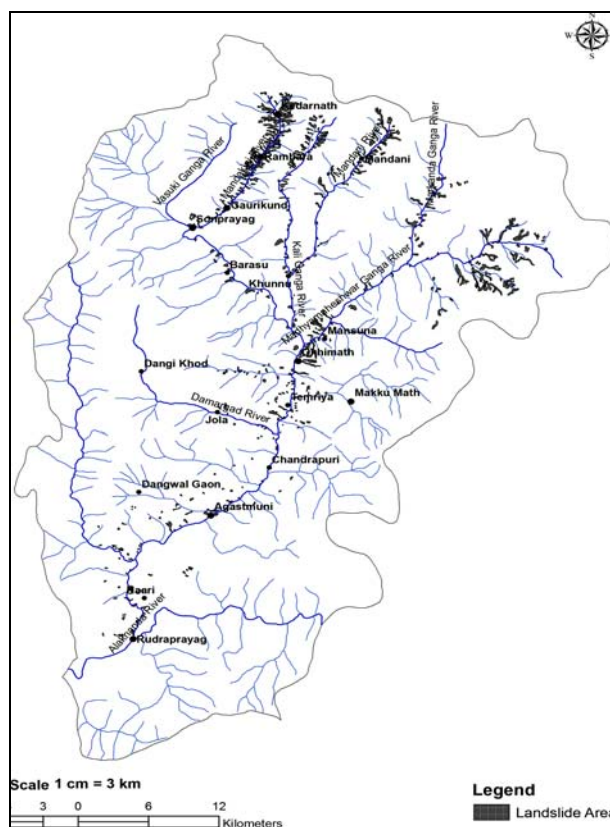
Fig. 4. Landslide affected areas of Rudraprayag district

Downstream villages of Rambara, Gaurikund and Sonprayag were washed away. The river Mandakini served as the axis of the catastrophe in the region. The landslide map of the district (Fig. 4) shows the severity of the calamity.
